**THE BUREAU OF OCEAN ENERGY MANAGEMENT,  
REGULATION AND ENFORCEMENT**

**REPORT REGARDING THE CAUSES OF THE APRIL 20, 2010  
MACONDO WELL BLOWOUT**

**September 14, 2011**

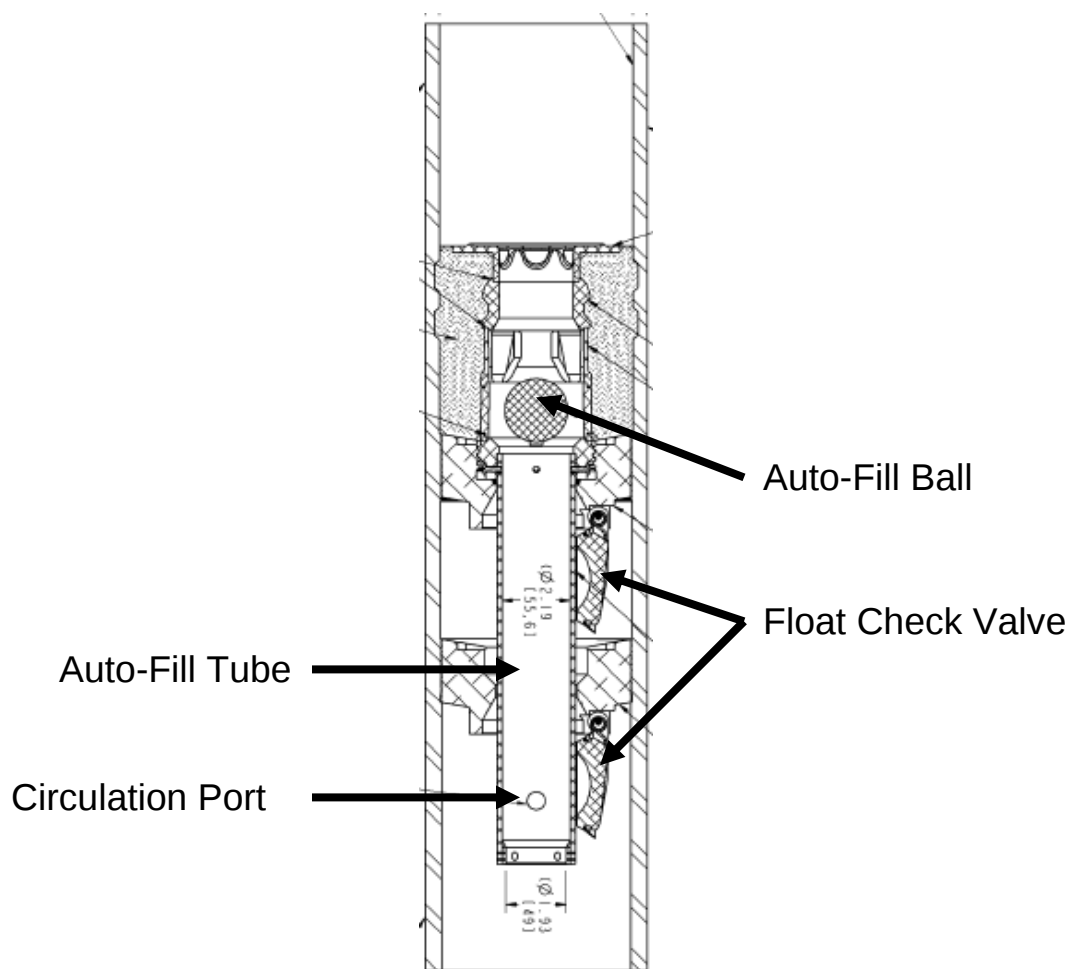
Figure 4 – Float Collar Utilized in the Macondo Well

As discussed above, the float collar was set at 18,115 feet measured depth, within the primary hydrocarbon reservoir sands (see Figure 2, above). Typically, an operator sets the float collar below the primary hydrocarbon sands to allow for perforation of the pay zone without the need to drill out the float equipment to get below the pay zone during the completion of the well. In addition, the lower primary sand was less than 100 feet from the bottom of the production casing shoe.<sup>116</sup> Normally, an operator would set the production casing shoe 200 to 300 feet below the primary sand to improve the chances of proper isolation of the pay sand.

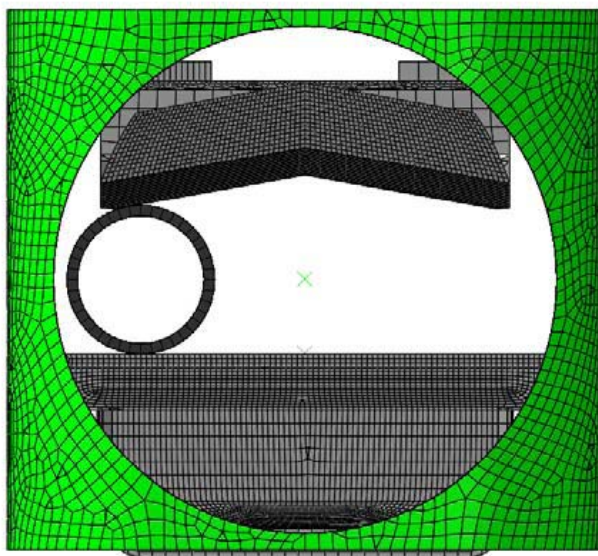
A forensic examination of the BOP stack revealed that elastic buckling of the drill pipe had forced the drill pipe up against the side of the wellbore and outside the cutting surface of the BSR blades. As a result, the BSR did not completely shear the drill pipe and did not seal the well. The buckling of the drill pipe, which likely occurred at or near the time when control of the well was lost, was caused by the force of the hydrocarbons blowing out of the well; by the weight of the 5,000 feet of drill pipe located in the riser above the BOP forcing the drill pipe down into the BOP stack; or by a combination of both. As a result of the failure of the BSR to completely cut the drill pipe and seal the well, hydrocarbons continued to flow after the blowout.

Figure 12 – Off-center drill pipe (Source: DNV)
