**Macondo Well—  
*Deepwater Horizon* Blowout  
Lessons for Improving Offshore Drilling Safety**

# **Macondo Well–*Deepwater Horizon* Blowout: Lessons for Improving Offshore Drilling Safety**

Committee for Analysis of Causes of the Deepwater Horizon Explosion, Fire, and  
Oil Spill to Identify Measures to Prevent Similar Accidents in the Future

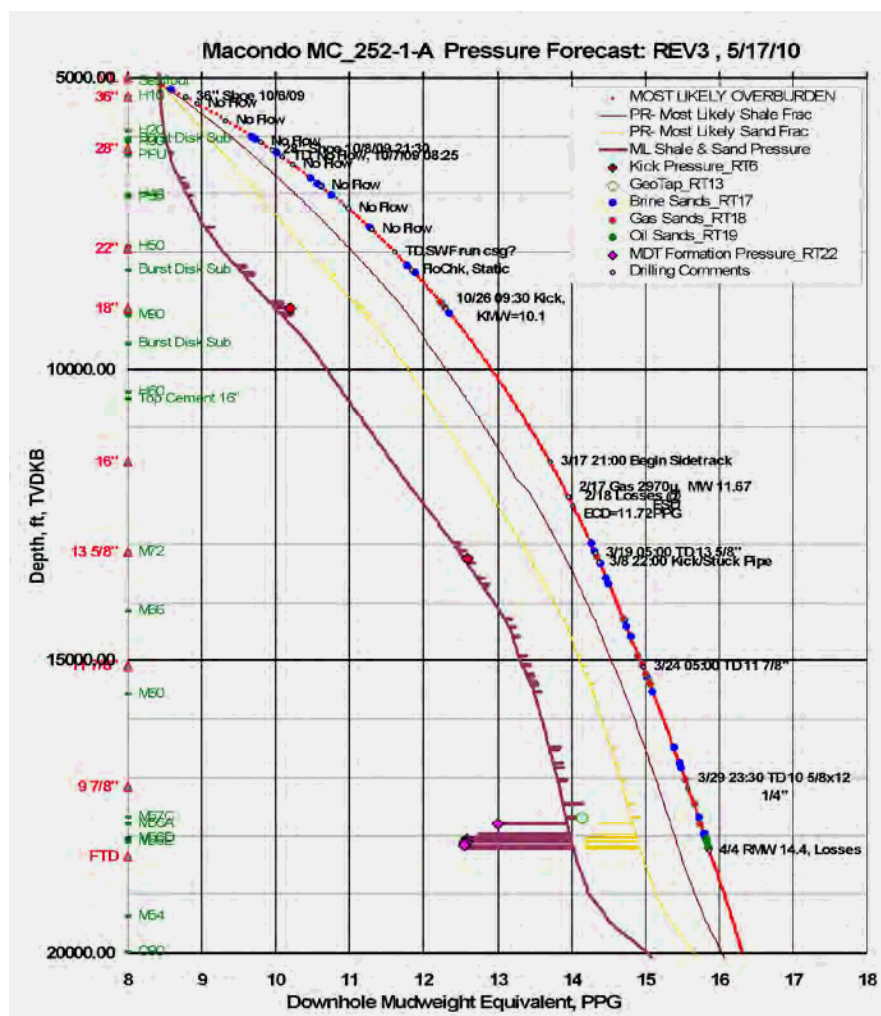
2. In the course of drilling at 13,250 feet, a kick occurred, and the lower annular blowout preventer (BOP) was closed in response. During well control operations, the drill string became stuck and was severed at 12,147 feet. The drill string and hole below 12,147 feet were abandoned, and subsequent well drilling deviated slightly to go around the abandoned materials left in the original hole. The 13  $\frac{5}{8}$ -inch liner was run at 13,145 feet, which was shallower than planned, to allow the well to be drilled safely past the higher pressure reservoir that had been encountered. The 11  $\frac{7}{8}$ -inch liner was used at 15,103 feet to seal the reservoir and allow for the use of higher mud weights than had been anticipated. Mud weight was to be kept between the curves for pore pressure and fracture pressure, as shown in Figure 2-3.

**FIGURE 2-3** Overburden stress, fracture gradients in the shale and sands and pore pressure in the Macondo well. The equivalent mud weight (EMW), expressed in pounds per gallon (ppg), must be higher than the pore pressure to avoid flow from the well and lower than the fracture gradient to prevent accidental hydraulic fracturing. Note the small separation between the values at depths below 18,000 ft. Source: BP Post-Well Subsurface Description of Macondo well (MC0252\_1BP1) v3. July 26, 2010. Reprinted with permission; copyright 2010, BP.

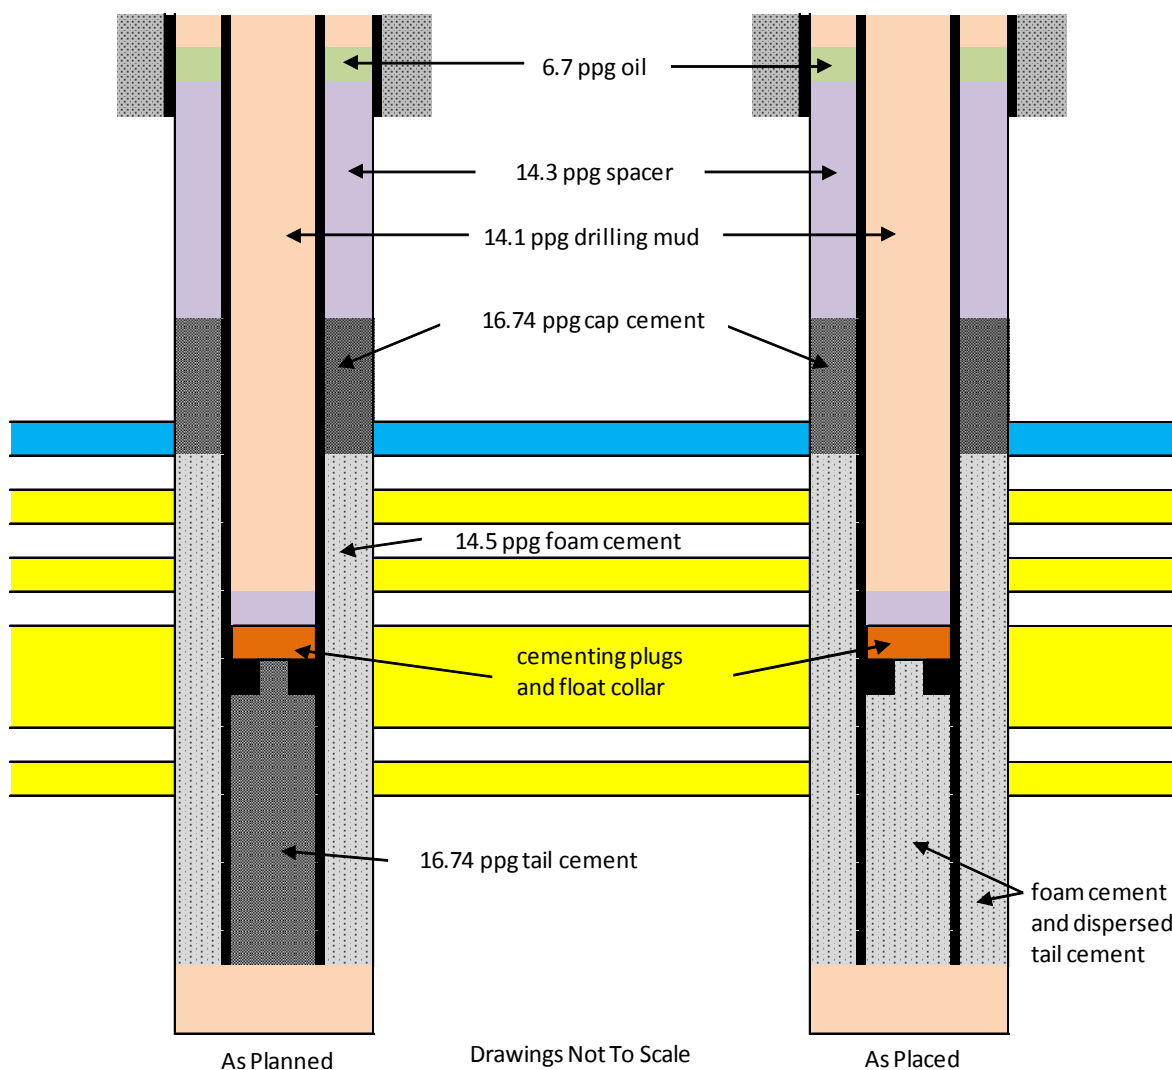
**FIGURE 2-5** Planned cement location and likely cement location after pumping. Source: Committee.

The last of the cement (tail cement) was to be un-foamed Class H plus retarder and other standard additives. This slurry was mixed at a density of 16.74 ppg and was intended to remain inside the shoe track at the bottom of the casing. As such it was meant to provide a high-quality, high-compressive-strength flow barrier inside the shoe track at the bottom of the casing. When this slurry was pumped, it was immediately on top of and in contact with the 66 percent-quality foam cement that had a density of about 6 ppg near the surface. The heavier slurry, being on top of the foam cement slurry, was gravitationally unstable and thus could have fallen into the lighter foam. The tail cement might have fallen all the way through the foam, unless it was stopped by viscous forces, or it might have mixed with the foam and changed the quality of the foamed cement. In either event, the tail cement slurry remaining inside the shoe track at the end of pumping would be dispersed in the foam and would not retain its intended composition; that is, there would be no concentration of dense tail cement inside the casing as originally planned (see Figure 2-5, right side).

**Finding 2.4:** The sequence of fluids used to cement the Macondo well included a low-density foamed slurry followed by a dense un-foamed tail slurry. The foam cement was designed to have a density of 14.5 ppg at the bottom of the well, but at the surface, where the foam was mixed, the density was extremely light at around 6 ppg. The tail slurry had a density of 16.7 ppg. Because of the extreme density imbalance, the heavy tail cement on top of the foamed cement would have been gravitationally unstable near the surface, and it probably fell into and perhaps through the foamed slurry. This would have had the unintended effect of leaving a tail slurry containing foamed cement in the shoe track at the bottom of the casing rather than leaving the heavy, un-foamed tail cement.

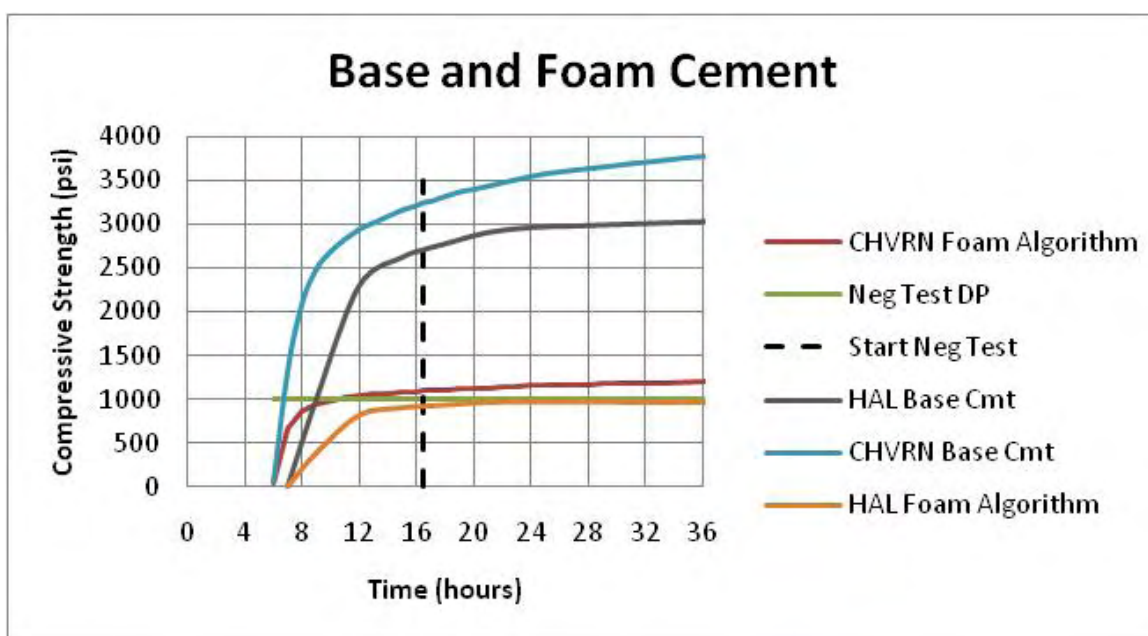
Figure 2-7 shows the time at which the negative pressure test was started after cement slurries were pumped into the Macondo well. The figure also shows a differential pressure of about 999 psi that was created between the reservoir pressure and the reduced hydrostatic pressure inside the casing during the negative test (see Appendix C for the calculation). Figure 2-7 indicates that the foamed cement using the Chevron data would have just barely established the strength required to resist crushing under the differential pressure imposed by the negative test, assuming that the cement was not contaminated or altered by other events. The foamed cement using the Halliburton base data and the foam algorithm would not have achieved sufficient compressive strength. The positive pressure test<sup>8</sup> of the casing that was performed before the negative pressure test would not have affected the cement because the cement plugs within the well would have supported this increased pressure.

**FIGURE 2-7** Uncontaminated cement compressive strength tests (DP = differential pressure). Source: Committee.

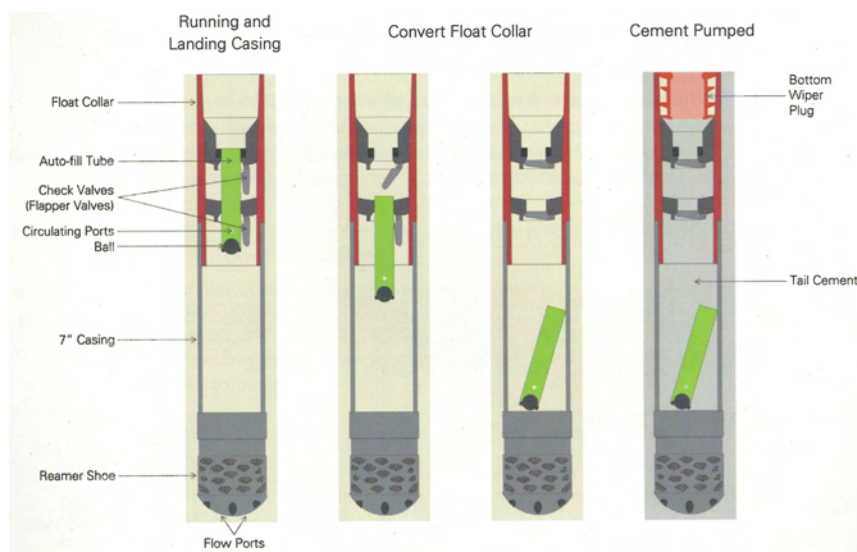
**FIGURE 2-8** Float collar with flapper valves and differential fill tube. Source: BP 2010, p. 71. Reprinted with permission; copyright 2010, BP.

Several factors pointed to the probable failure of the flapper valves in the float collar. Once circulation was established, the pump rate never exceeded 4 barrels per minute (bpm), when at least 5 bpm was needed to shear the differential fill tube holding the flapper valves open. This indicates that the flapper valves likely remained open. Another possibility is that sufficient debris remained inside the shoe track to prevent the tube from falling out of the floats but allowing the ball to be pumped out the end of the tube. A third possibility is that the flappers in the valves were damaged when the higher pressure cleared the plug in the casing.

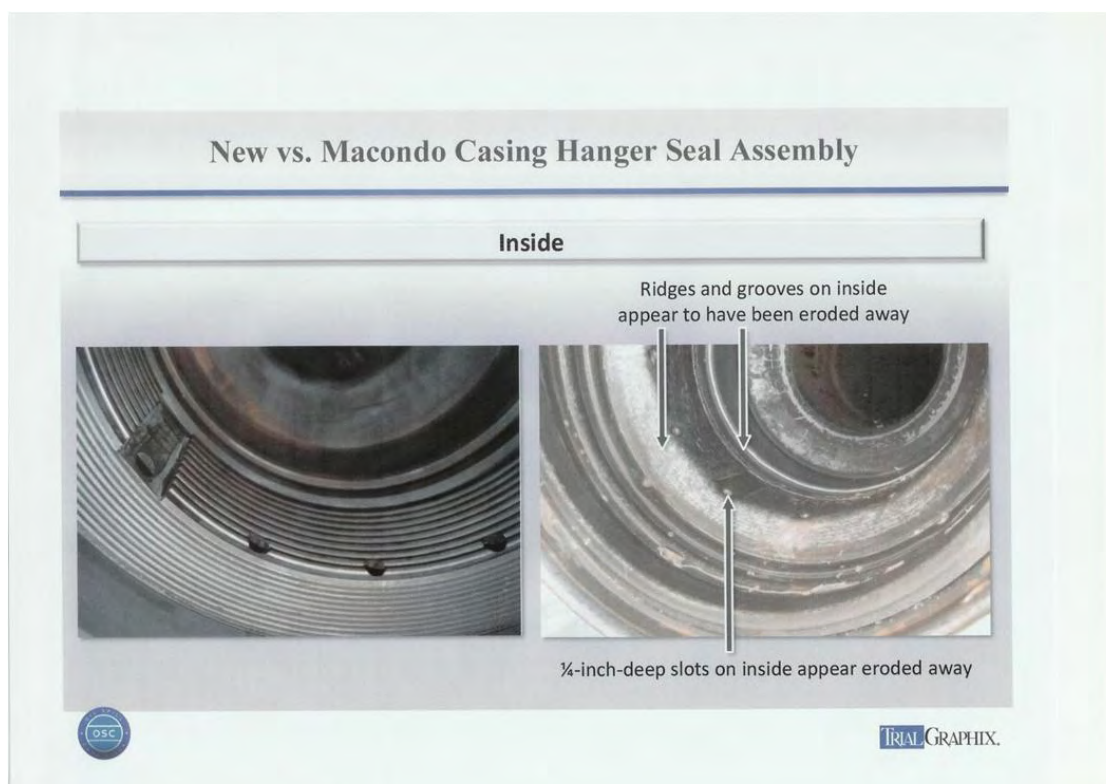
Identification of the probable hydrocarbon flow path up the Macondo well can provide insights for well design considerations to enhance the safety of drilling operations. Pictures of the long string casing hanger that was recovered, shown as Figure 2-9, indicate that hydrocarbon flow was up the inside of the casing, as the inside of the hanger showed signs of fluid erosion while the outside did not. However, under the correct circumstances, flow could have been up the annulus. Because the lock-down sleeve was not installed, the margin of safety against the potential for flow up the annulus was reduced.

**FIGURE 2-9** View inside casing hanger. Source: National Oil Spill Commission, Presentation on the BP Deepwater Horizon Oil Spill and Offshore Drilling, Slides 118-120.

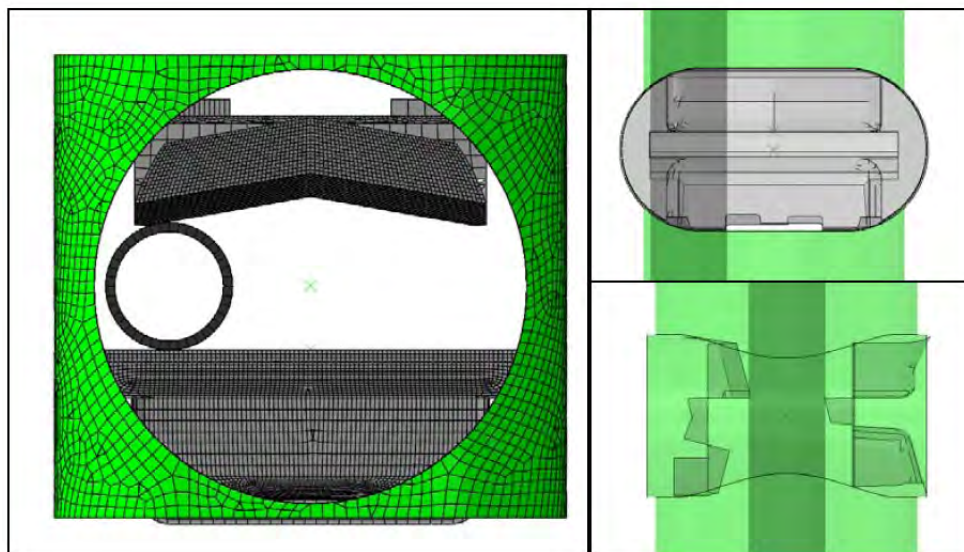
The central finding of the DNV report was that the BSR blades' could not shear a 5½-inch drill string and then seal against each other because the drill string was located on the side and not the center of the BOP annulus. This finding appears to be strongly supported by a wide range of corroborating physical evidence, and it has been embraced by Transocean (Transocean 2011, I, 137). The asymmetric dents in the drill pipe sheared by the rams [impressed into steel 0.350inch thick (DNV 2011a, I, 128)] credibly matched to the geometry of the ram blocks (DNV 2011a, I, 100) leave little room for alternative explanations. In addition, there is compelling physical evidence that the upper annular preventer above the BSR and the VBRs below the BSR were activated and closed on the drill string before the BSR was activated, centering the drill string in the BOP annulus in close proximity to the BSR. Thus, the DNV conclusion that the drill string was under significant compressive load also appears logical and perhaps the only feasible mechanism for pushing the drill string so far off center in such a short distance (27.3 feet) (DNV 2011a, I, 151). The consequence of not extending the blades on the BSR to cover the complete BOP annulus can be clearly observed in Figure 3-5. As was noted earlier, West Engineering dropped the one straight and one V blade BSR configuration from its study in 2004 because of the higher shearing pressure this design required. It is also apparent that this configuration had less ability to center an off-center drill string than a double V ram design would have evidenced. The gaps on the sides of the BSR blades, and their obvious inability to shear any pipe that was in this area, indicate that the possibility of pipe being off center was not considered in this design.

**FIGURE 3-5** Finite element analysis model of BSR blade surfaces and off-center drill pipe. Source: DNV 2011b, p. 15. Reprinted with permission; copyright 2011, DNV.

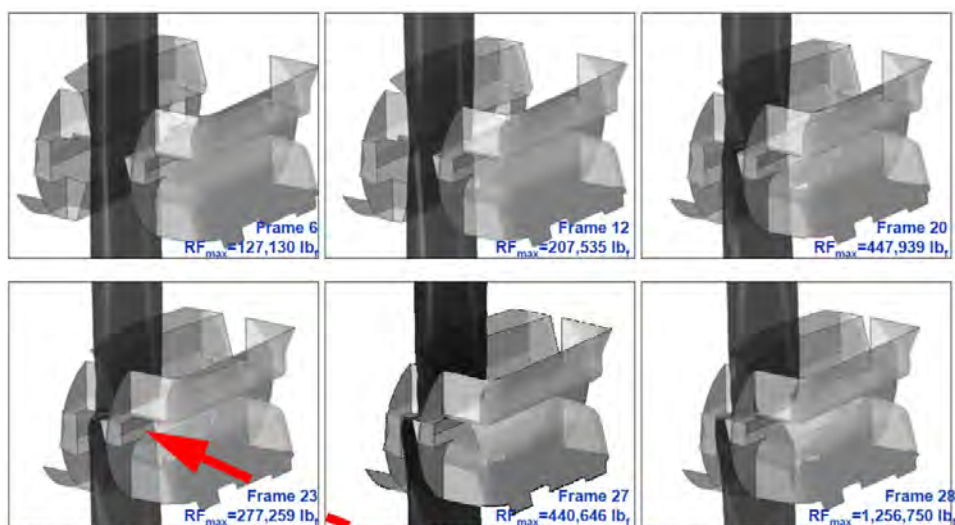
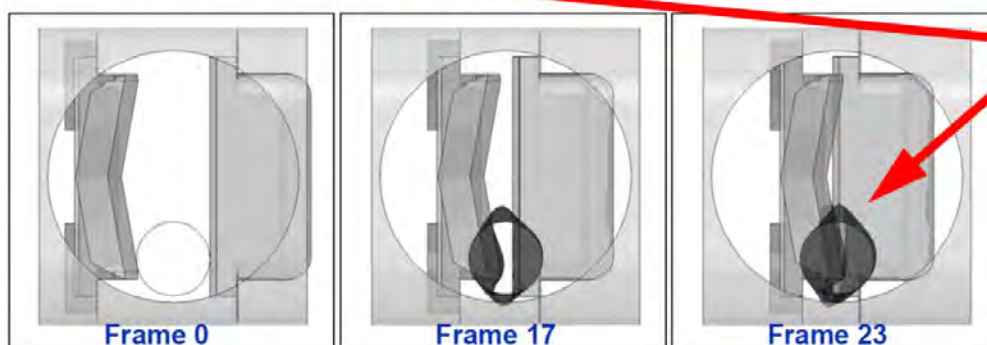
**Revised Figure 140 Progression of Off-Center BSR Shear Model - Isometric View**

The weight of the evidence appears to support the conclusion of BP and DNV that the BSR was activated by the autoshear, but for additional reasons not addressed in their reports. All parties appear to agree that the upper and middle VBRs successfully sealed the well a minute or two before the explosions, accounting for the large pressure spike in the drill string starting at 21:47 (BP 2010, 105). Both these VBRs were found with their ST locks set (DNV 2011a, I, 31), meaning that they stayed applied, irrespective of flow or pressure, until the BOP was retrieved. Thus, until they were eventually eroded, the annulus of the BOP remained sealed by these VBRs. During this period the only flow path for hydrocarbons from the formation to the rig was the drill string. If Transocean was correct, this flow path was interrupted “within minutes” by the AMF activating the BSR. It appears undisputed that the BSR sheared the drill string off center in the manner illustrated by Figure 3-6, which is from the DNV report addendum (DNV 2011b, 17). If Transocean is correct and the AMF functioned “within minutes” of 21:50, then the entire hydrocarbon communication with the Macondo well must have been through the small flow area that would exist at that time from the sheared end of Pipe Segment 94 (End 94B) (DNV 2011a, I, 95). Note on Figure 3-6 in Frame 23 that the sheared pipe end is shown with only 277,000 pounds of ram load applied where the BSR will ultimately apply approximately 900,000 pounds of ram force at the regulated pressure of 4,000 psi (DNV 2011a, 14). Thus, substantially less cross-sectional flow area will be available to well hydrocarbons than is shown in Frame 23.

Total flow area available from the well with VBRs sealed until the drill pipe erodes with only ~1/3 the ultimate ram closing load applied.

**FIGURE 3-6** Progression of off-center BSR shear model, isometric view (*top*) and top view showing deformation of drill pipe outside of shearing blade surfaces (*bottom*). Source: DNV 2011b, p. 17. Reprinted with permission; copyright 2011, DNV.
