**Macondo Well—  
*Deepwater Horizon* Blowout  
Lessons for Improving Offshore Drilling Safety**

# **Macondo Well–*Deepwater Horizon* Blowout: Lessons for Improving Offshore Drilling Safety**

Committee for Analysis of Causes of the Deepwater Horizon Explosion, Fire, and  
Oil Spill to Identify Measures to Prevent Similar Accidents in the Future

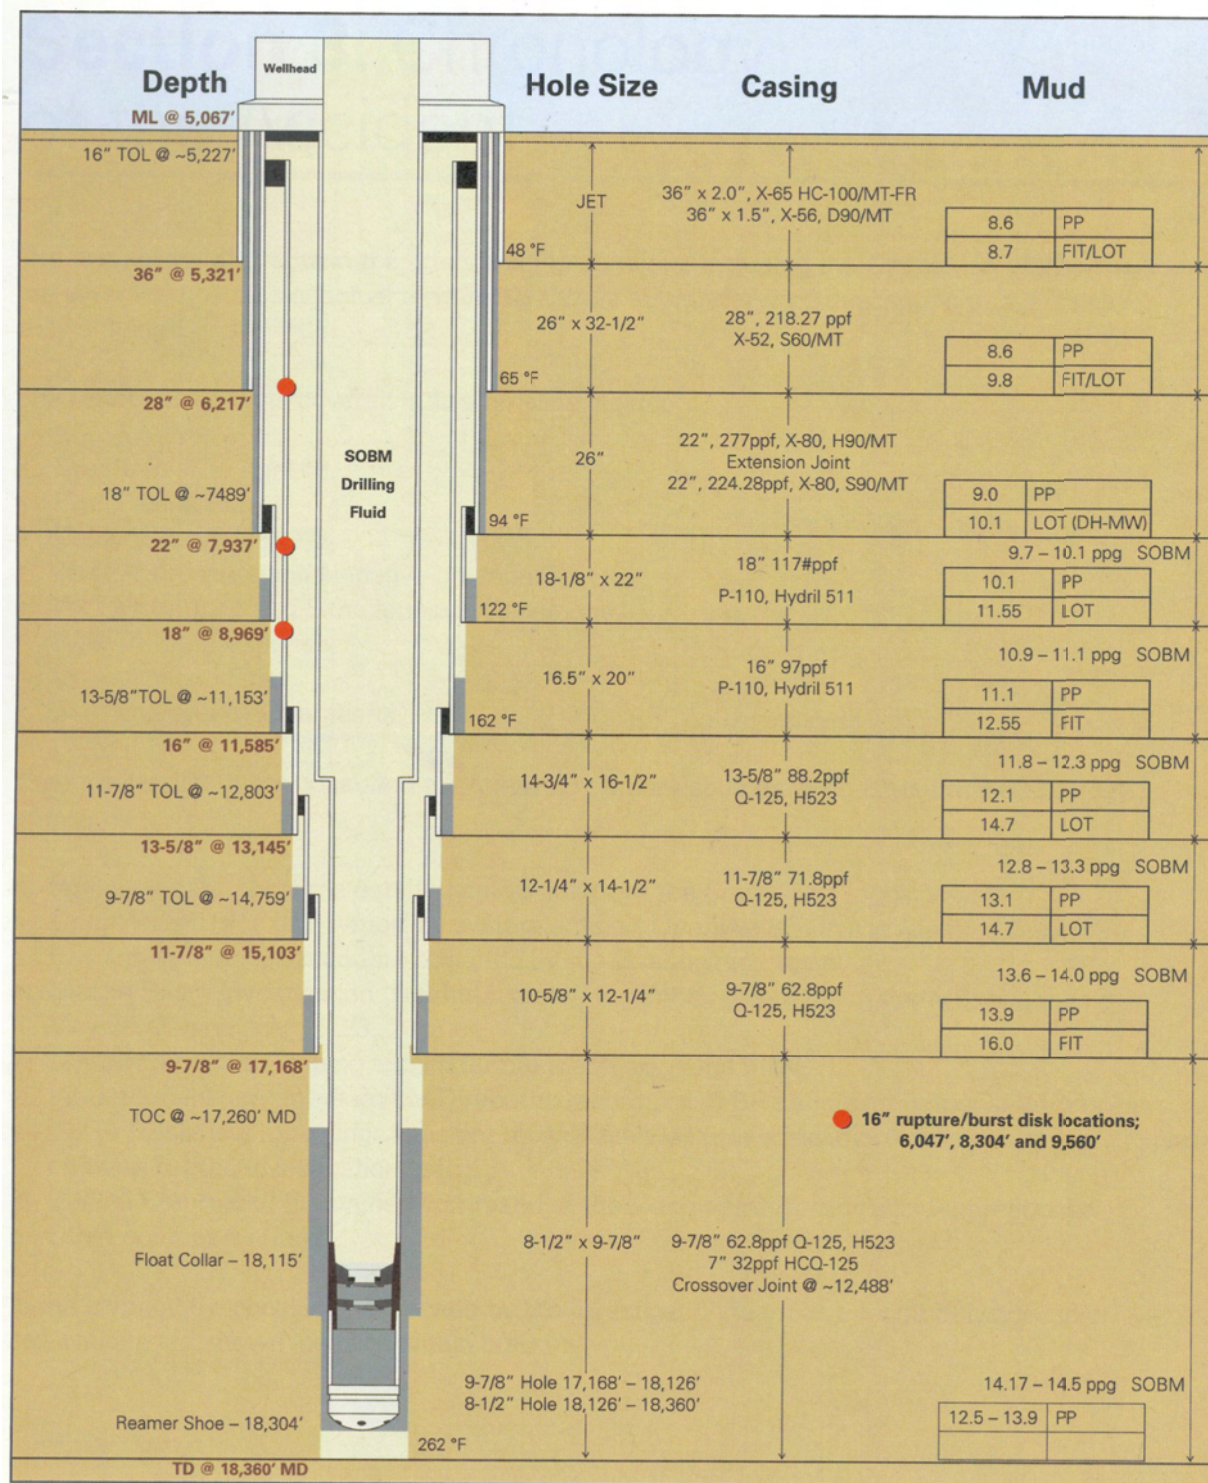
2. In the course of drilling at 13,250 feet, a kick occurred, and the lower annular blowout preventer (BOP) was closed in response. During well control operations, the drill string became stuck and was severed at 12,147 feet. The drill string and hole below 12,147 feet were abandoned, and subsequent well drilling deviated slightly to go around the abandoned materials left in the original hole. The 13  $\frac{5}{8}$ -inch liner was run at 13,145 feet, which was shallower than planned, to allow the well to be drilled safely past the higher pressure reservoir that had been encountered. The 11  $\frac{7}{8}$ -inch liner was used at 15,103 feet to seal the reservoir and allow for the use of higher mud weights than had been anticipated. Mud weight was to be kept between the curves for pore pressure and fracture pressure, as shown in Figure 2-3.

**FIGURE 2-2** Final well bore architecture for Macondo well. Source: BP 2010, p. 19. Reprinted with permission; copyright 2010, BP.

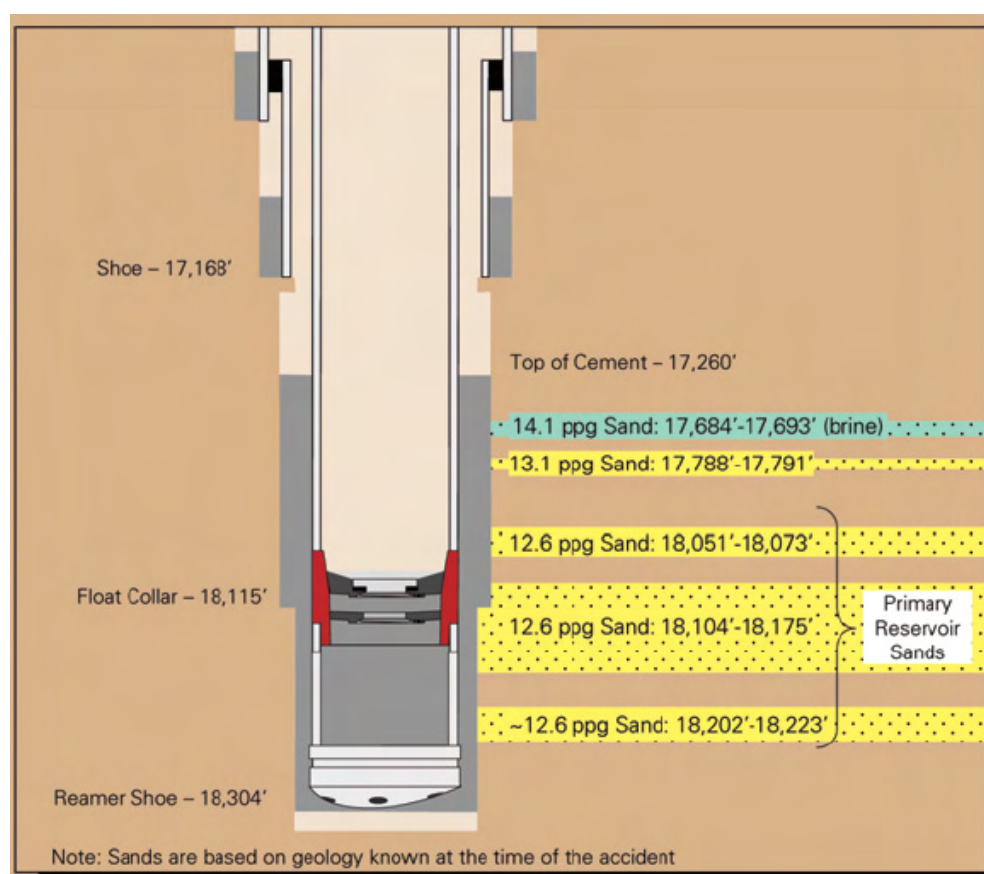
To continue drilling to the planned final depth of 19,650 feet, the reservoirs that had been discovered with decreasing pore and fracture pressures with depth (Figure 2-4) were to be sealed with the 9  $\frac{7}{8}$  inch  $\times$  7-inch combination casing string and cement. However, because the hole diameter that could be drilled below the 7-inch casing was considered too small to be practical, so the well was terminated at 18,360 feet.

**FIGURE 2-4** Variation of pore pressure in the open hole section of the Macondo well expressed in pounds per gallon. Source: BP 2010, p. 54. Reprinted with permission; copyright 2010, BP.

According to the BP accident investigation report (BP 2010), the final open hole section of the well contained several reservoirs with decreasing pore pressure with depth. As shown in Figure 2-4, the largest pore pressure was estimated at 14.1 ppg in a salt-water-bearing reservoir, and the lowest was estimated at 12.6 ppg in the hydrocarbon-bearing reservoir. The largest pore pressure required that the mud weight be at least this high to prevent salt water flow from the reservoir. The fracture mud weight was just above 14.2 ppg, as evidenced by lost circulation at 18,260 feet (see BP 2010, 17-18 and Figure 2-3). This caused the margin of safety between the equivalent circulating density (ECD)<sup>4</sup>, shown in Figure 2-3 as an equivalent mud weight, and the fracture mud weight to be very small. The operations associated with pumping cement into the annulus without fracturing one of the lower-pressure reservoirs were therefore difficult.

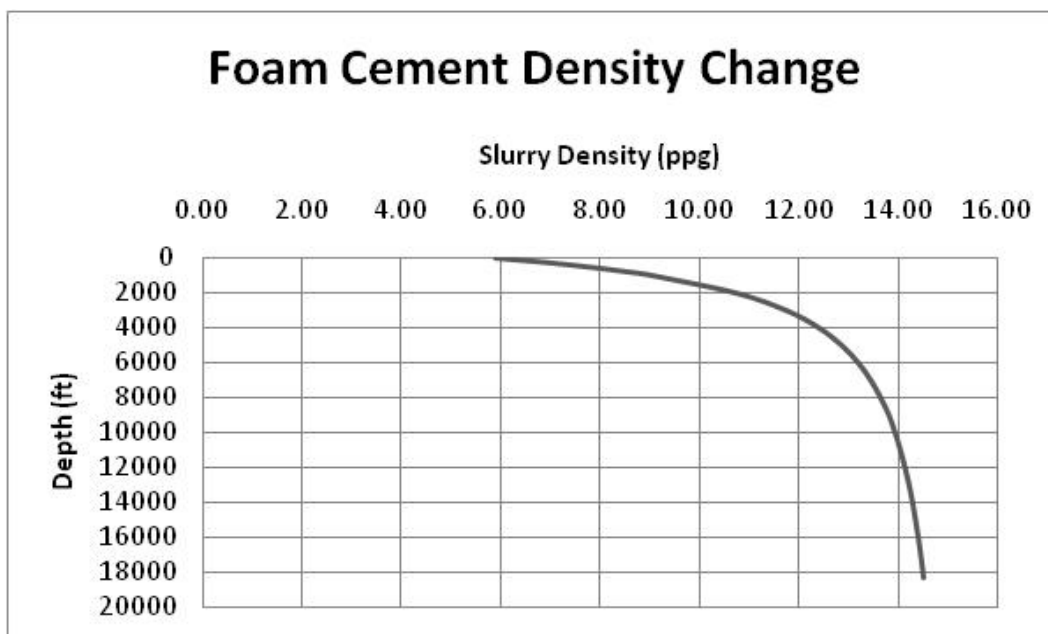
To make a foamed cement slurry that has a density of 14.5 ppg at the bottom of the well, the foam quality<sup>6</sup> had to be 17.4 percent at bottom hole conditions of 245°F and 13,321 psi (see Appendix C for the calculations).<sup>7</sup> At the surface, where the conditions in the mixer were about 600 psi and 60°F, the foam quality had to be 66 percent, producing a foamed slurry of about 6 ppg, to allow for the substantial compression and heating that were to occur as the foam was pumped to the bottom of the well. (For reference, fresh-water has a density of 8.33 ppg.). Figure 2-6 shows the calculated foam density versus depth.

**FIGURE 2-6** Calculated foam density versus depth during pumping. Source: Committee.

**Finding 2.4:** The sequence of fluids used to cement the Macondo well included a low-density foamed slurry followed by a dense un-foamed tail slurry. The foam cement was designed to have a density of 14.5 ppg at the bottom of the well, but at the surface, where the foam was mixed, the density was extremely light at around 6 ppg. The tail slurry had a density of 16.7 ppg. Because of the extreme density imbalance, the heavy tail cement on top of the foamed cement would have been gravitationally unstable near the surface, and it probably fell into and perhaps through the foamed slurry. This would have had the unintended effect of leaving a tail slurry containing foamed cement in the shoe track at the bottom of the casing rather than leaving the heavy, un-foamed tail cement.

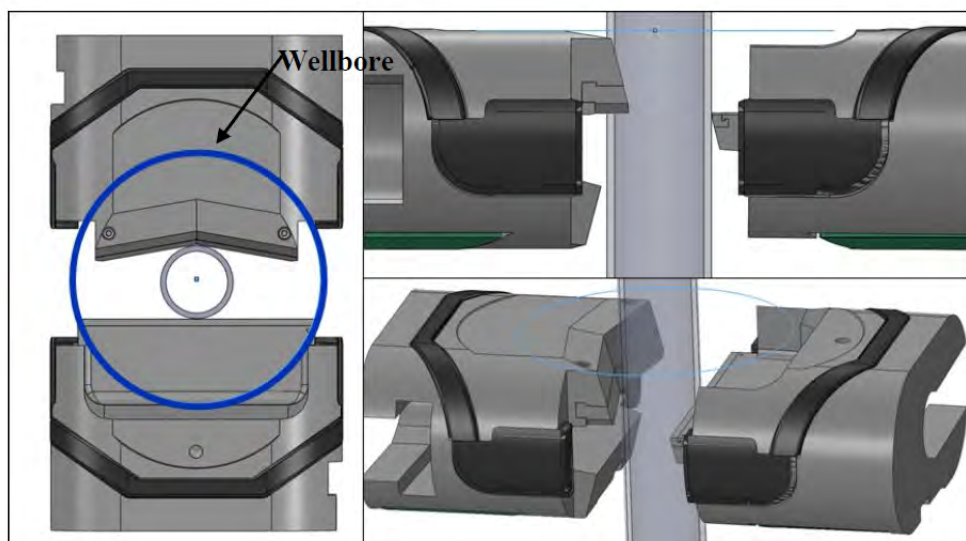
The BSR was the uppermost of the five rams of the BOP stack, and is shown for nominal operation in Figure 3-2. A BSR is like a massive metal scissors with two opposing blades that are designed to slice through the drill pipe as the blades pass by each other, as shown in Figure 3-3, seal the well. The design intent was that, when the two blades of the “scissors” passed by each other and fully penetrated into the “side packers” on the other side, the seal across the BOP bore was to be effected and thus seal off the entire throat of the BOP. The BSR was, by design, a device of last resort in a hierarchy of well-control strategies: when all else failed, the BSR was to slice the drill pipe and seal the well. Even if no drill pipe was present in the BOP system, the BSR was designed to seal the well when the “scissor blades” passed by each other and into the side packers.

**FIGURE 3-2** Sketch of intended nominal operation of Blind Shear Ram in the Macondo well. Source: DNV 2011a, I, p. 155. Reprinted with permission; copyright 2011, DNV.

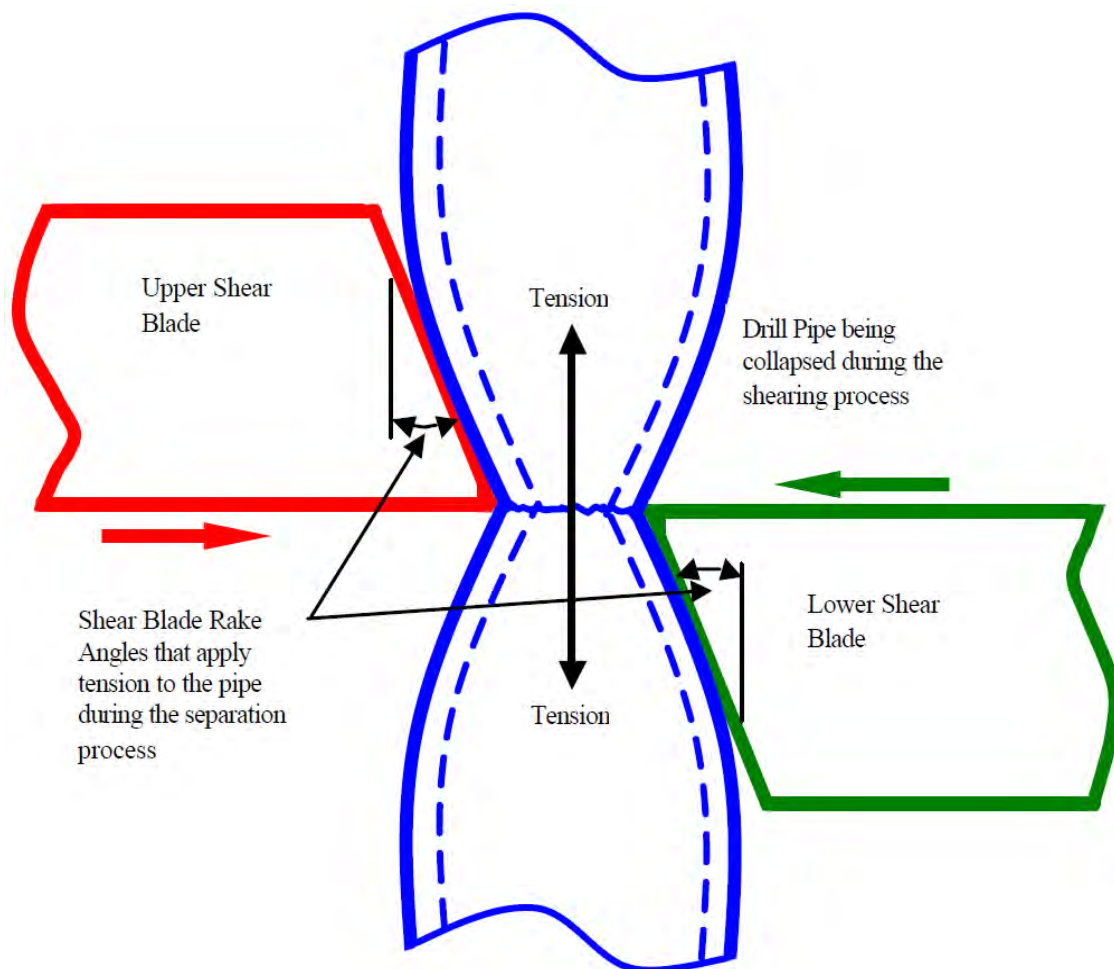
**FIGURE 3-3** Upper and lower shear blades crushing the drill pipe and beginning the shearing (or breaking) operation. Source: West Engineering Services, Inc. 2004, p. 2-2. Reprinted with permission; copyright 2004, West Engineering Services, Inc.

- In the cutting process, the shear rams collapse or mash the pipe, and as the pipe is crushed, the blade angle pulls the metal into tension and breaks it in a tensile mode of failure (Figure 3-3). Depending on the ram blade design, the blade can flatten the pipe to a great extent, which in turn can prevent the ram from closing completely and sealing even if the pipe is centered.

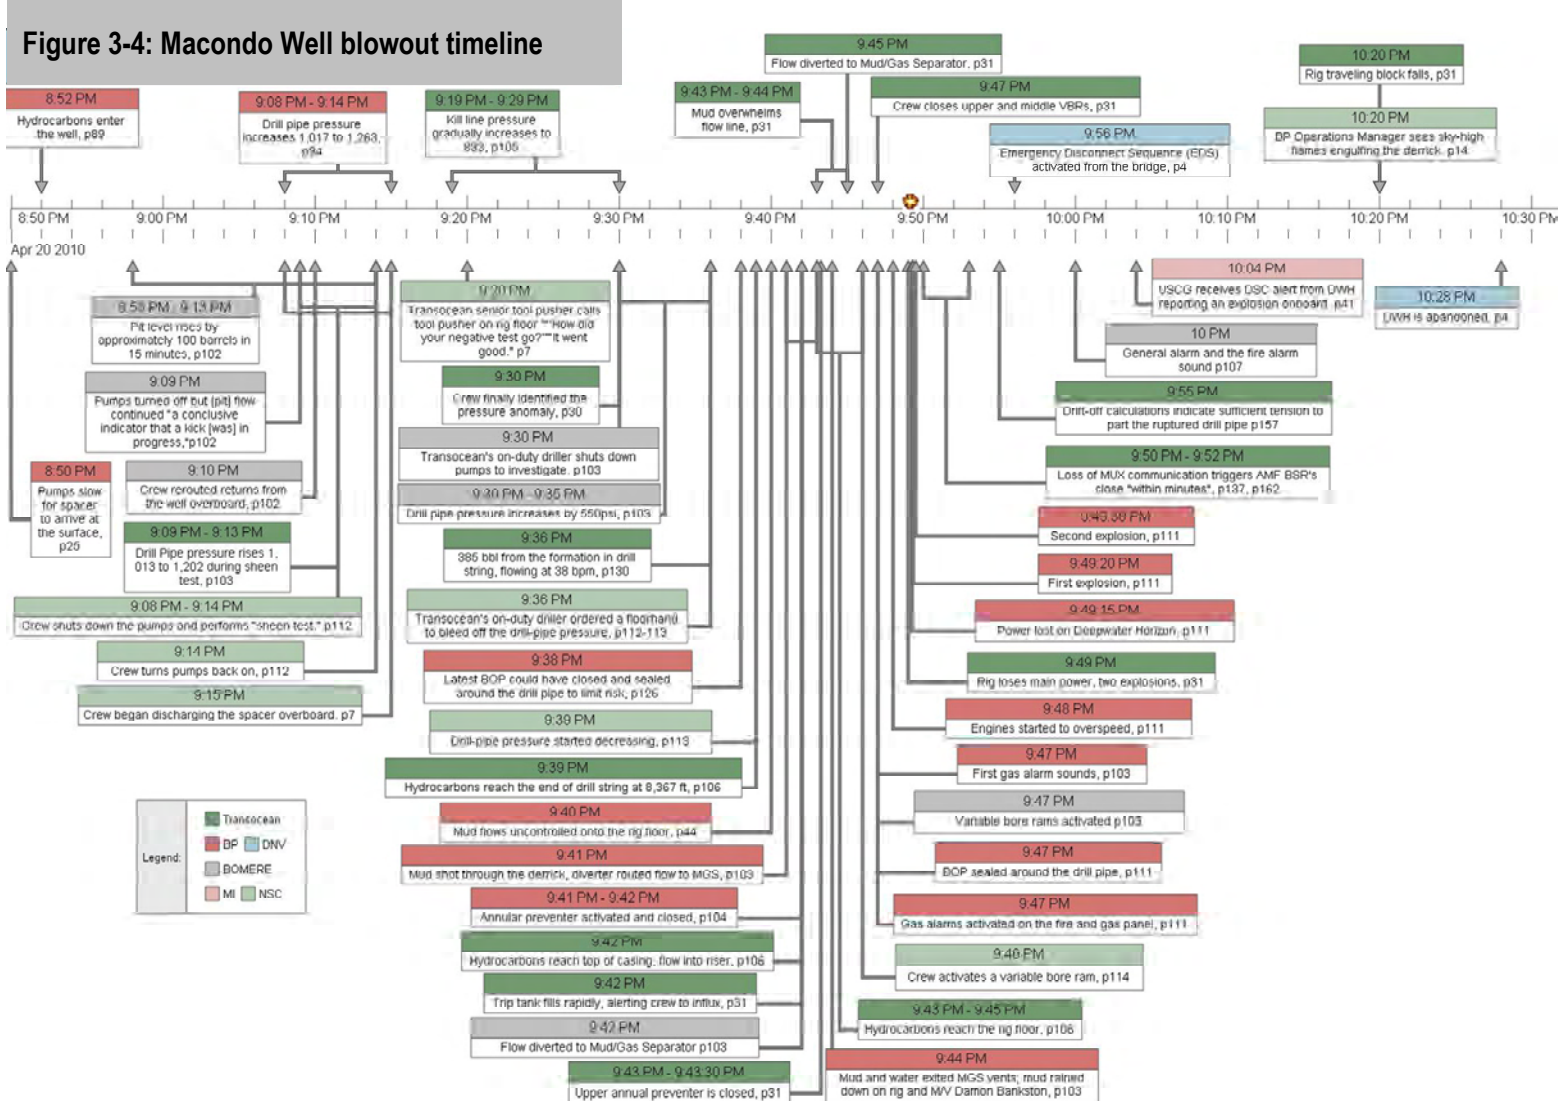
**FIGURE 3-4** Macondo well blowout timeline. Source: Committee.

**Summary Finding 3.1:** The loss of well control was not noted until more than 50 minutes after hydrocarbon flow from the formation started (see timeline in Figure 3-4), and attempts to regain control by using the BOP were unsuccessful. The BSR failed to sever the drill pipe and seal the well properly, and the EDS failed to separate the lower marine riser and the *Deepwater Horizon* from the well.

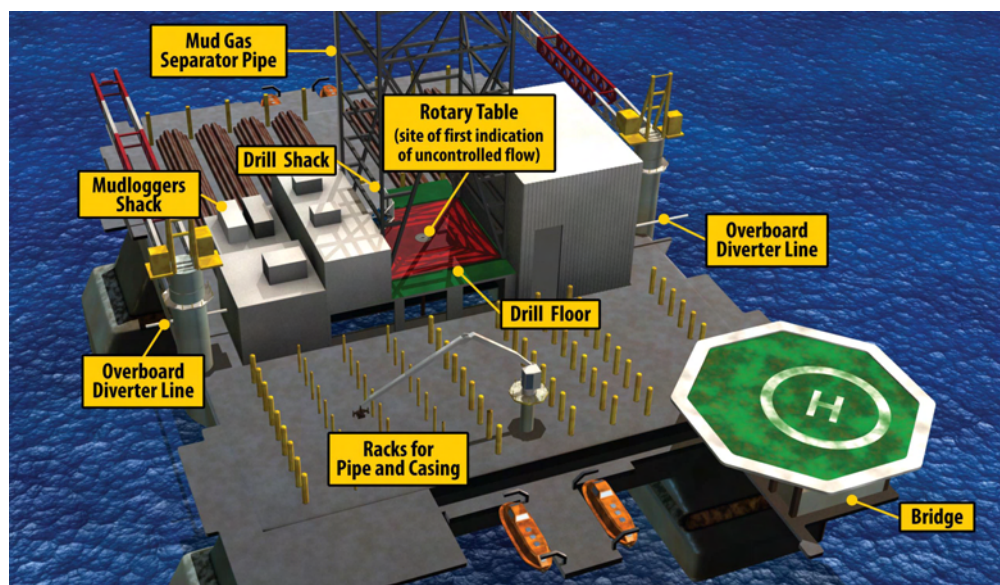
After accounting for all survivors, it was determined that the eleven killed were crew last seen on the Drill Floor, the Mud Pump Room and the Shaker House. All of those areas were broadly exposed to the gaseous hydrocarbon flow erupting from the well through the mud gas separator system vents.<sup>21</sup> There was no protection system built into these working areas of the rig to deflect the effects of explosion from those who were exposed.

**FIGURE 4-2** Illustration of the main deck of the *Deepwater Horizon*. The rig crew could send fluids from the well overboard through the overboard diverter lines. Alternatively, the crew could route flow from the well to a mud-gas separator pipe and vent hydrocarbon gas before sending the mud to the mud pits (not shown). Source: Chief Counsel's Report 2011.
